# Manhole Inspection Summary

Manhole # S21M1\_016MH

Insp Date: **4/30/08 10:32 AM**

**Location** Address: **3220 hollins ferry rd**

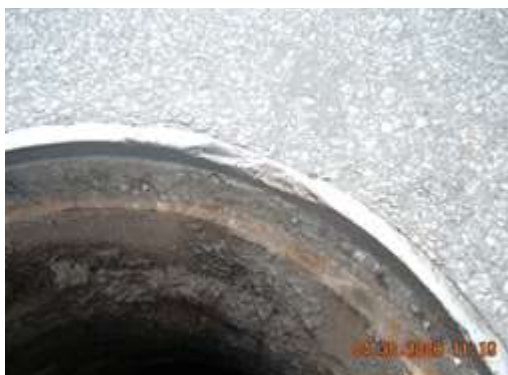
Misc. Defect 2

worn frame

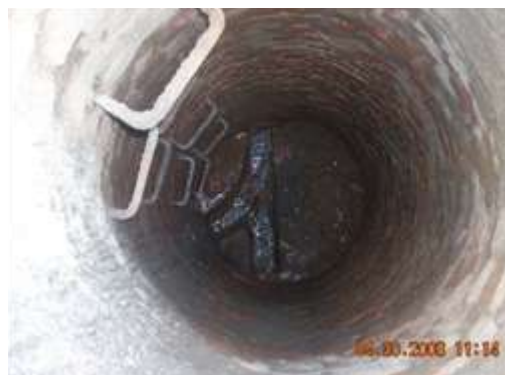
misc

Bench Debris

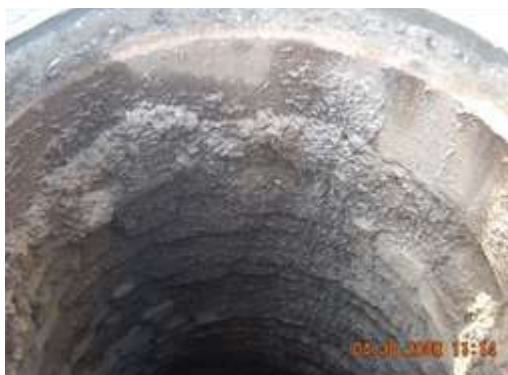
Defect 1

☒ **Leaks**

Frame leaks (inflow evidence)

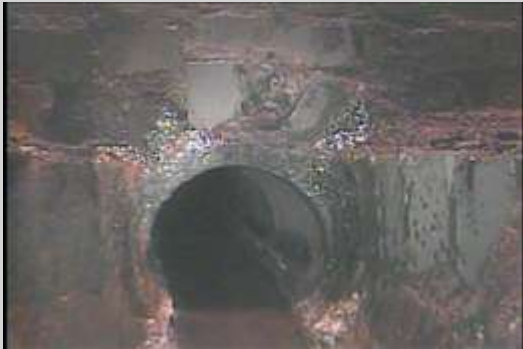
12 O'Clock Outflow

Pipe Height: **8.4** (in.) Rod and Bar (Angled)  
Pipe Material: **Clay** ☐ Pipe Lined  
Invert Depth: **14.80** (ft.) Flow Characteristics: **Slow**  
Deposits: ☒ None ☐ Mud ☐ Sludge ☐ Debris ☐ Grease  
Silt Depth: **0** (in.) Deposits Extent:  
Infiltration: **Evidence** Pipe Seal Cond: **Unknown**

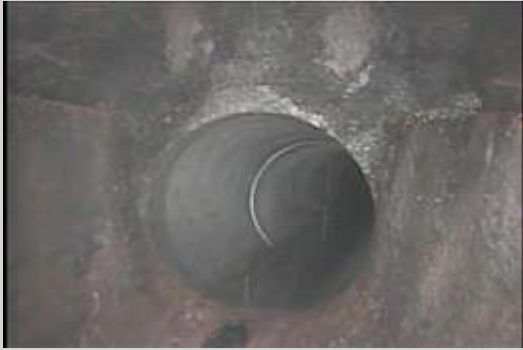
8 O'Clock Inflow

Infiltration: **Evidence** Pipe Seal Cond: **Unknown**
